REPORT

Saskatchewan Heavy
Construction Association

Impacts of Drainage on
Rural Municipality Infrastructure

JULY 2022

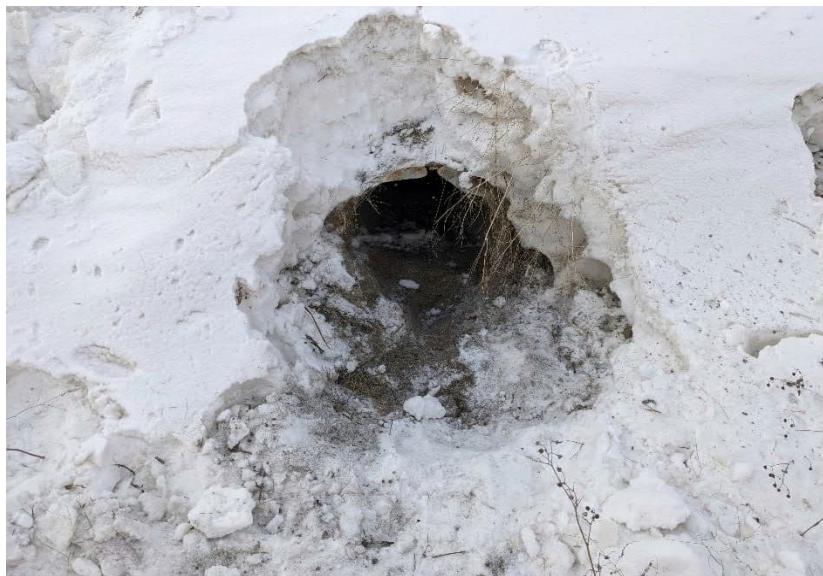
Road condition:	Arm River Road is a gravel road in good condition
Culvert performance:	Culvert is deformed and dirt has built up along bottom. Performance is not great
Utilities:	None
Natural obstructions	N/A

Description: Culvert Inlet

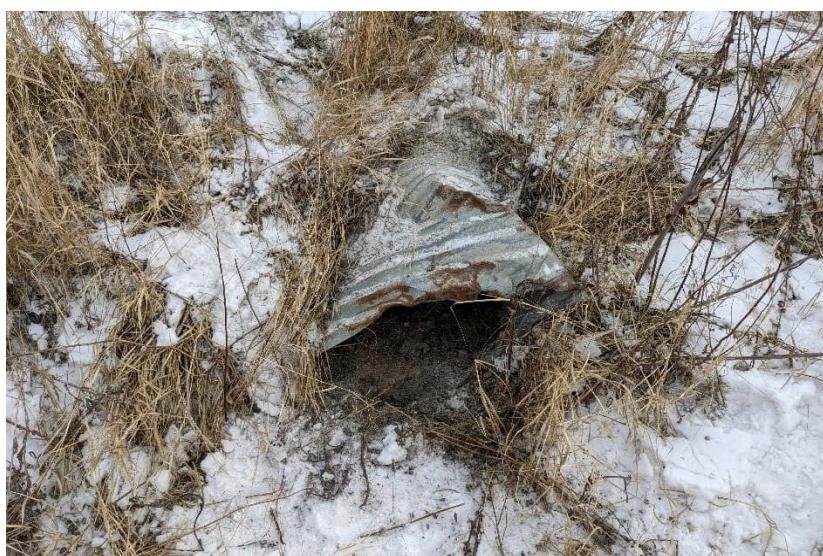
The outlet of Culvert 1 appears crushed and rusted with several inches of sediment transfer buildup. The culvert inlet is in decent shape with minimal sediment build-up. It appears that the culvert experiences relatively small flows regularly although the RM foreman said that this location "flooded to 14 feet above the road centerline in 2014". Judging from the faint rust lines marking the culvert walls, the typical flow depth is approximately 200 mm. There appears to be no runoff ponding on the inlet side of the road which indicates that the culvert generally functions well.

Description: Culvert Outlet

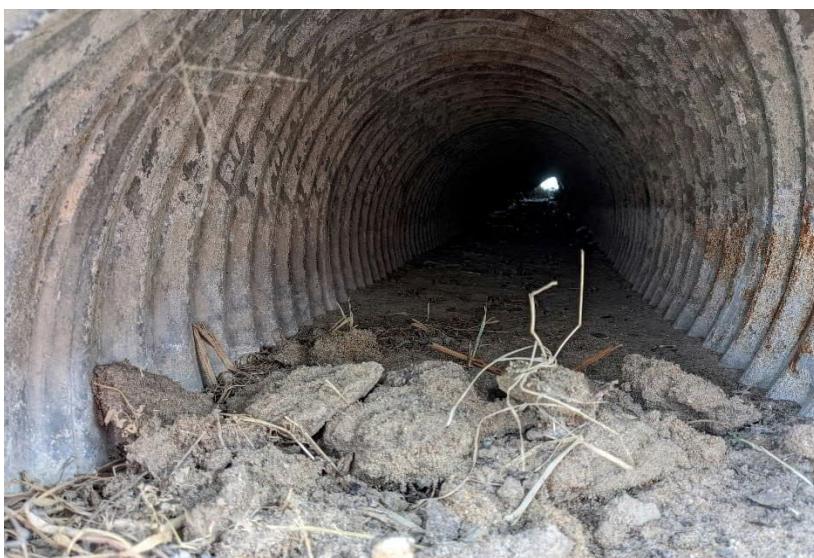
Description: Inside Culvert

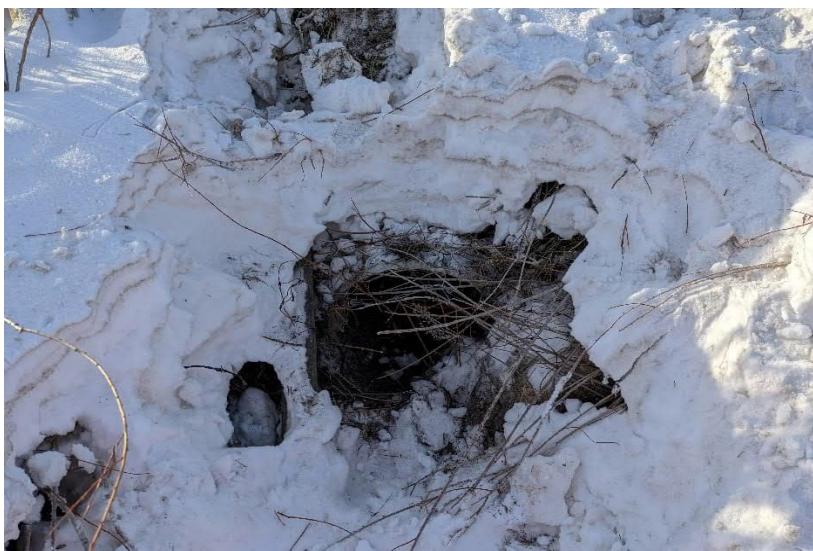
Description: Culvert Outlet

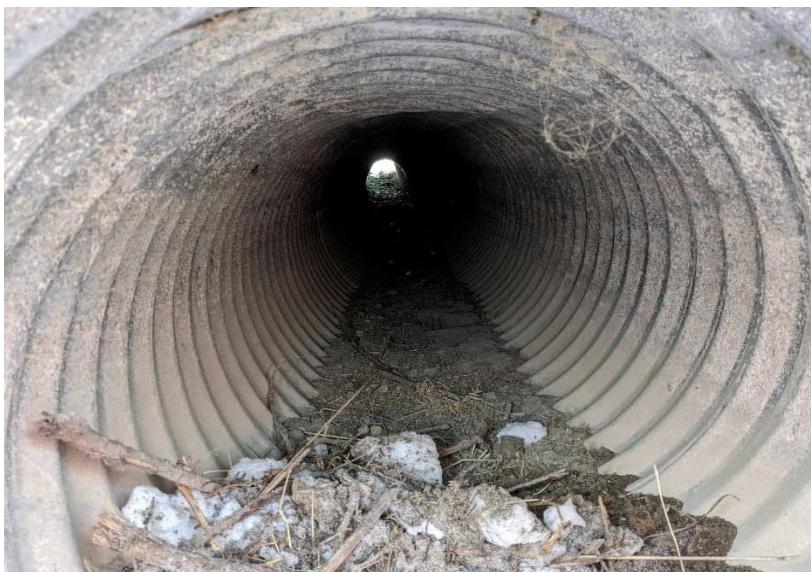
Both inlet and outlet of Culvert 2 appear to be in good condition, though the pipe appears to sag under the road. There is 150 mm of sediment buildup at the pipe outlet, though no standing water around the crossing indicates that it still functions relatively well. The pipe inlet was blocked by loose barbed wire and fence posts, as well as long grass. This made access difficult but doesn't seem to be blocking the flow. At the time of inspection, the culvert was dry but faint markings on the culvert walls indicate a typical high water level of 200 mm.

Description: Inside Culvert

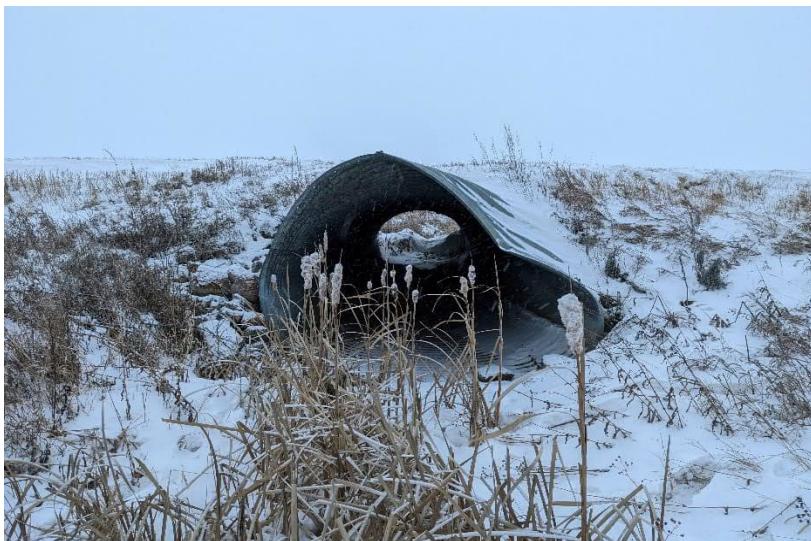
The top of Culvert 1 has been crushed on the inlet side and appears to be bowed under the road, likely due to a lack of proper cover. The area surrounding the inlet is marshy and covered in cattails with a defined drainage path at the outlet. The bottom half of the culvert pipe appears rusted on the inside. Though the culvert was dry at the time of inspection, rust lines on the culvert walls indicate that the typical high water flow depth is 400-500 mm. A marked underground Sasktel line was surveyed 45 m north of the pipe inlet.

Description: Culvert Inlet

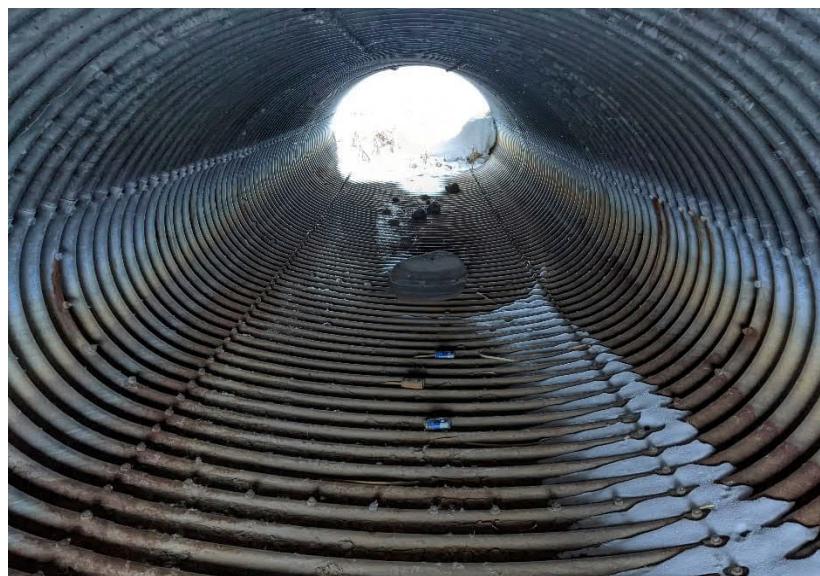
Culvert performance: Culvert seems to perform well, though bowed due to inadequate cover

Description: Inside Culvert

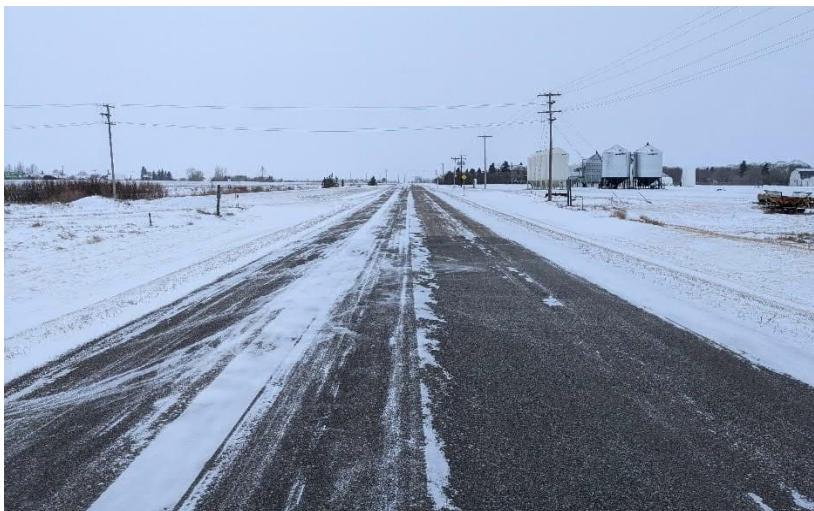
Culvert 2 has defined channels at both inlet and outlet. The pavement over the culvert appears newer than the rest of the highway which could indicate a recent washout, replacement, or an asphalt shim to fill potential settlement. The pipe itself appears in good condition from the outside but has extensive rust on the inner bottom half. The culvert was dry when inspected; however, rust markings on the culvert walls indicate a flow depth of more than half the culvert height. Marked utilities in the vicinity of the culvert include underground gas and telephone lines, and an overhead power line.

Description: Road

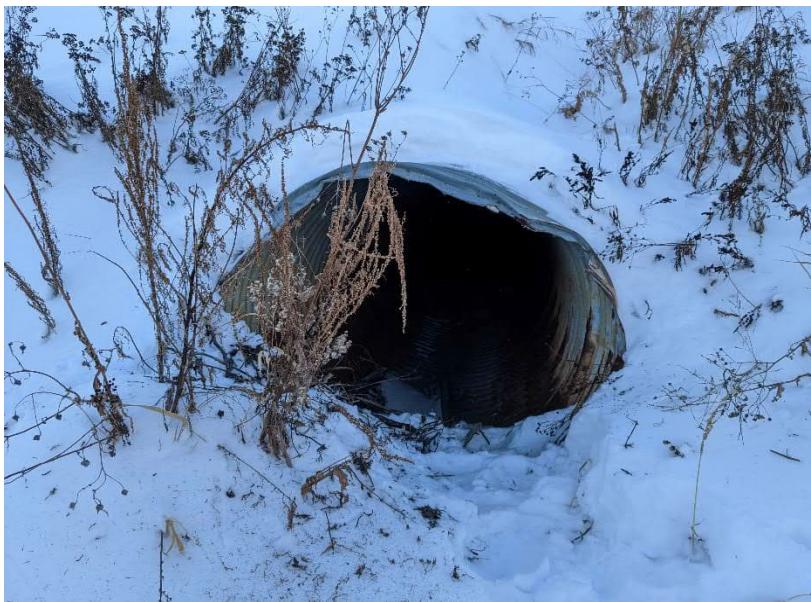
Natural obstructions Beaver dam at inlet

Description: Culvert Inlet

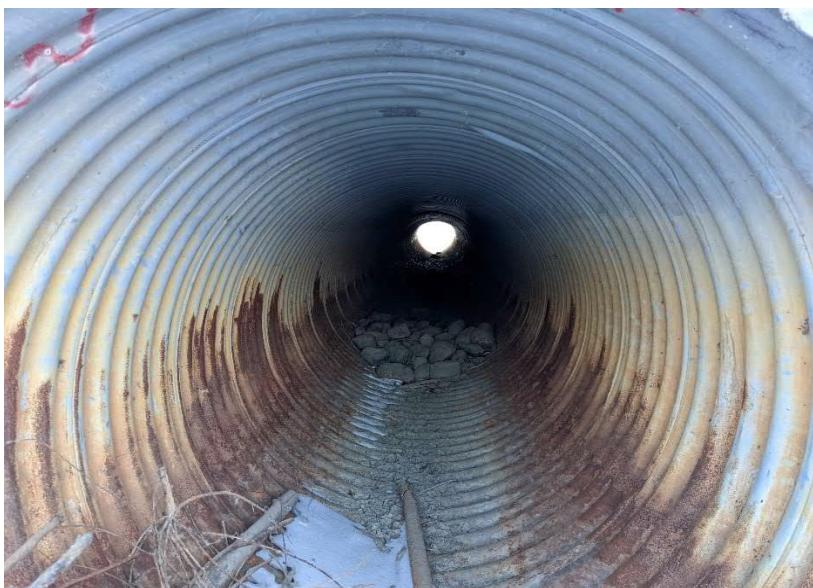
The culvert condition and shape were in fair condition with some bowing under the road. The gravel road is in good condition with the road centreline several metres higher than the culvert invert due to the depth of the drainage ditch. There is a beaver dam at the culvert invert and a small pile of rocks 5 m from the culvert outlet. Judging by rust markings on the culvert walls, the typical high water elevation is 300-400 mm above the culvert invert, though the culvert was dry at the time of inspection. There is also an overhead power line on the upstream property line.

Description: Inside Culvert
